## BendPak Technical Service Bulletin

### Power Unit Solenoid Position Adjustment

#### BendPak TSB 192-122025

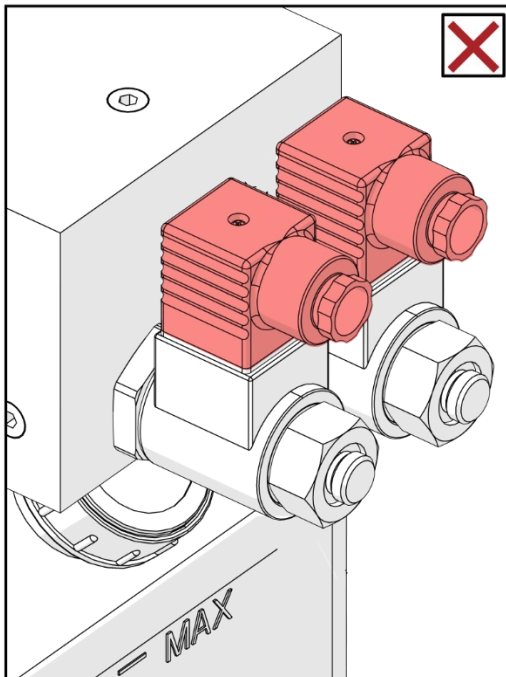
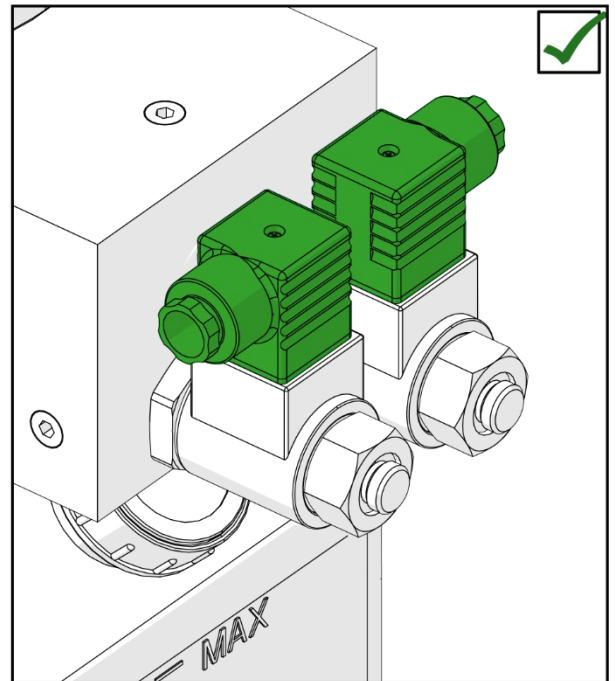
This Technical Service Bulletin describes the field adjustment of the electrical connection positions on two solenoid valves incorporated in power unit 5585153. This power unit is commonly supplied with Autostacker and P9000 series lifts by BendPak Inc. The initial production run of this power unit included solenoid valves positioned in a manner that allows the control wiring to physically prevent the closure of the Lift console. The correction is a simple rotation of the valve's connector body and removal of the vibration dampener from the power unit mounting.

4. Locate the lift cylinder solenoid electrical connectors on the power unit. The connectors highlighted below display the connectors in their ***incorrect and correct positions***.

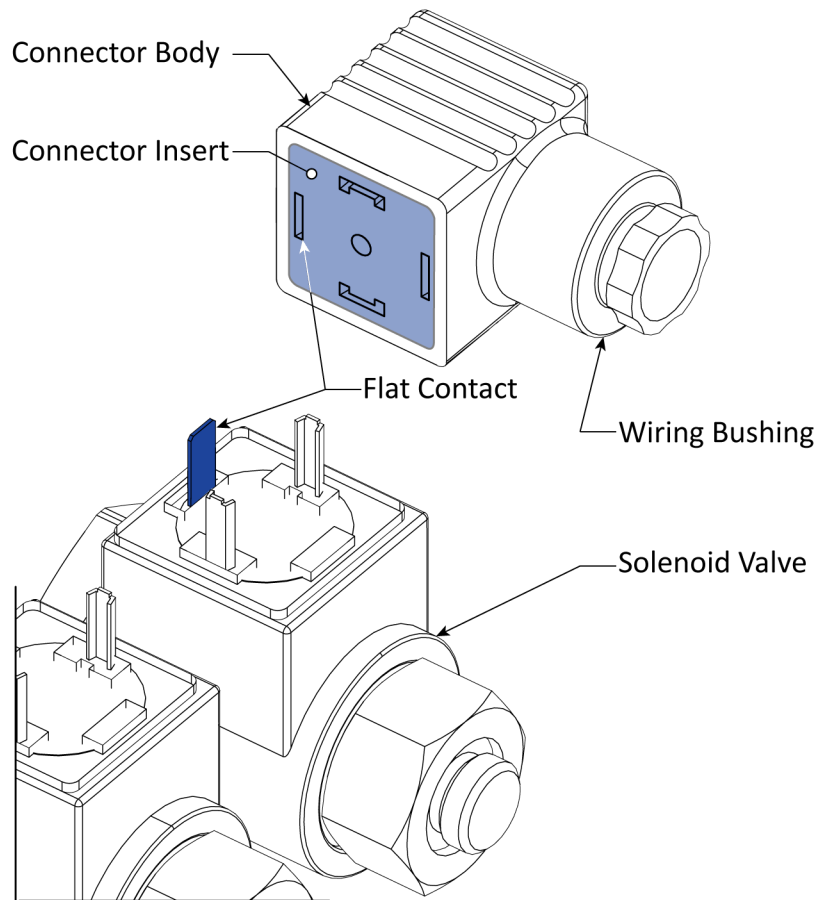
- 
7. Turn the connector over and examine the connector insert. Note the position of the flat contact in relation to the connector body and the wiring bushing.
